HR Duct and AHU Corrective Efforts

Performed September 2010

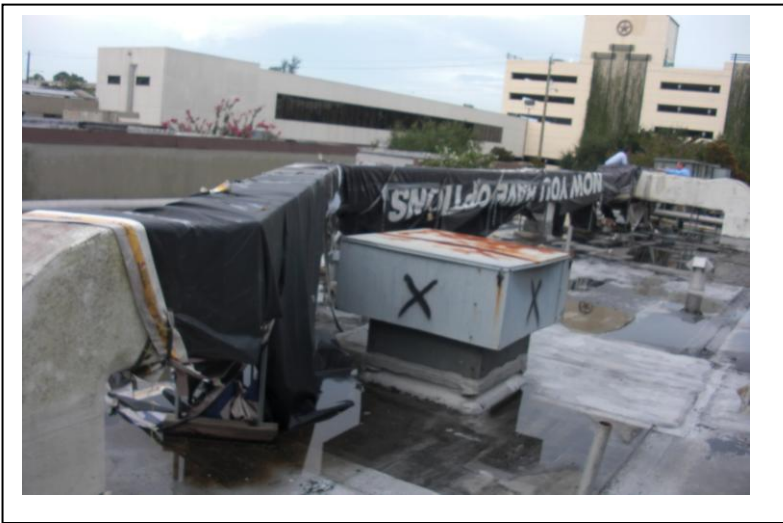
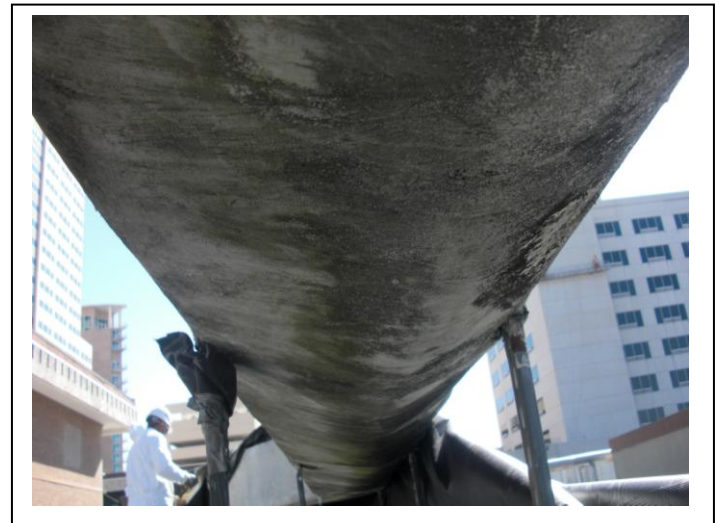
Duct prior to work

- Duct insulation was falling off as result of condensation moisture saturation
- Portions of the duct were rusting from the moisture saturation
- Several leaks were found in duct line
- AHU internally was in need of cleaning

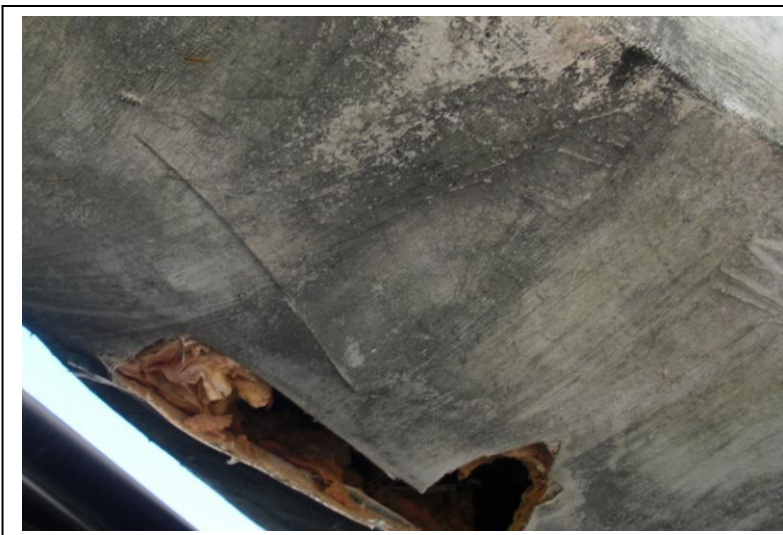
Bottom of duct has insulation that is belled out with water

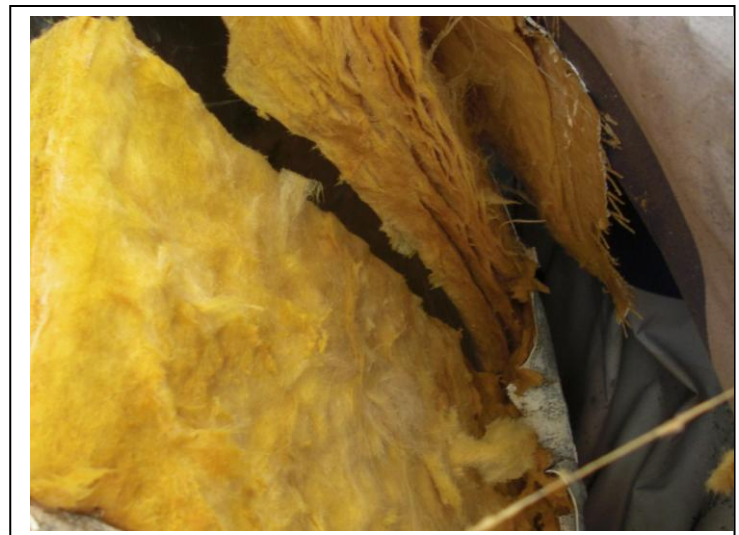
Moisture has broken through seal layer

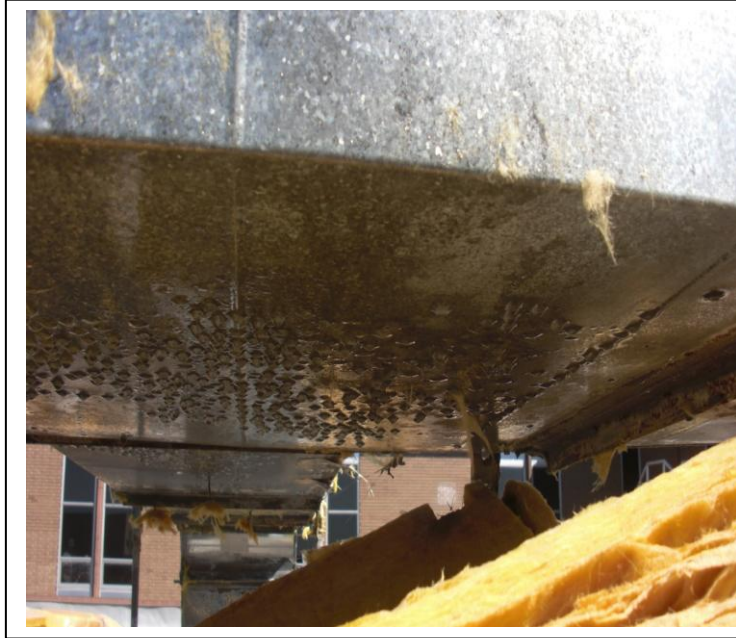
Uncovered bottom of duct

Wet insulation at unit discharge

Heavy condensation droplets

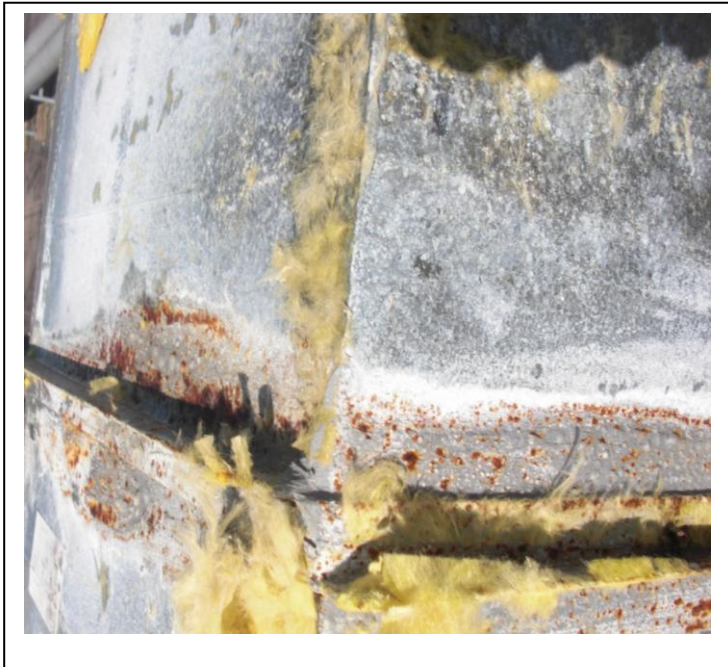
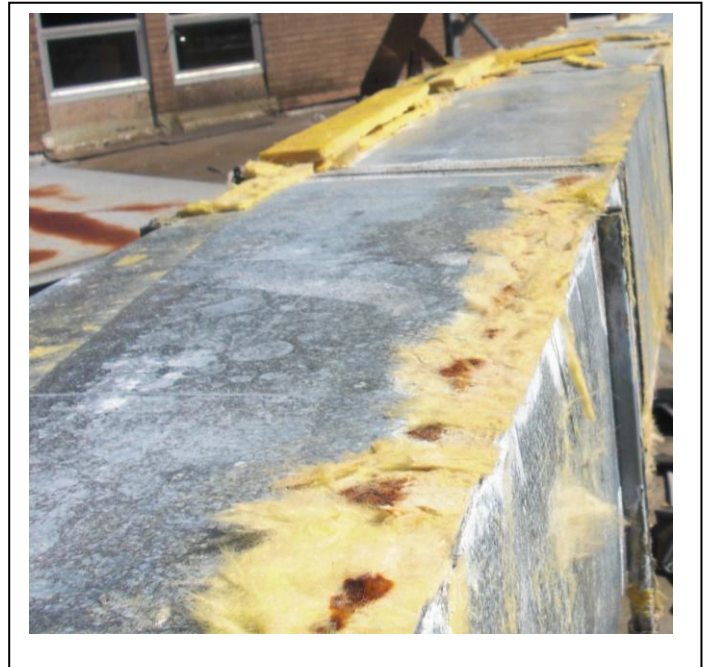
Effects of condensation

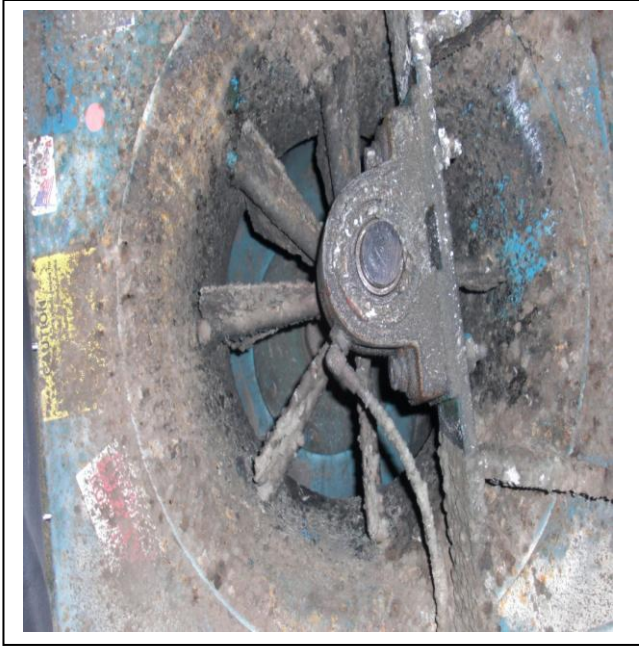
Before

Inside the unit
