El Toro – Clute Energy Efficiency Trial

Project Implementation

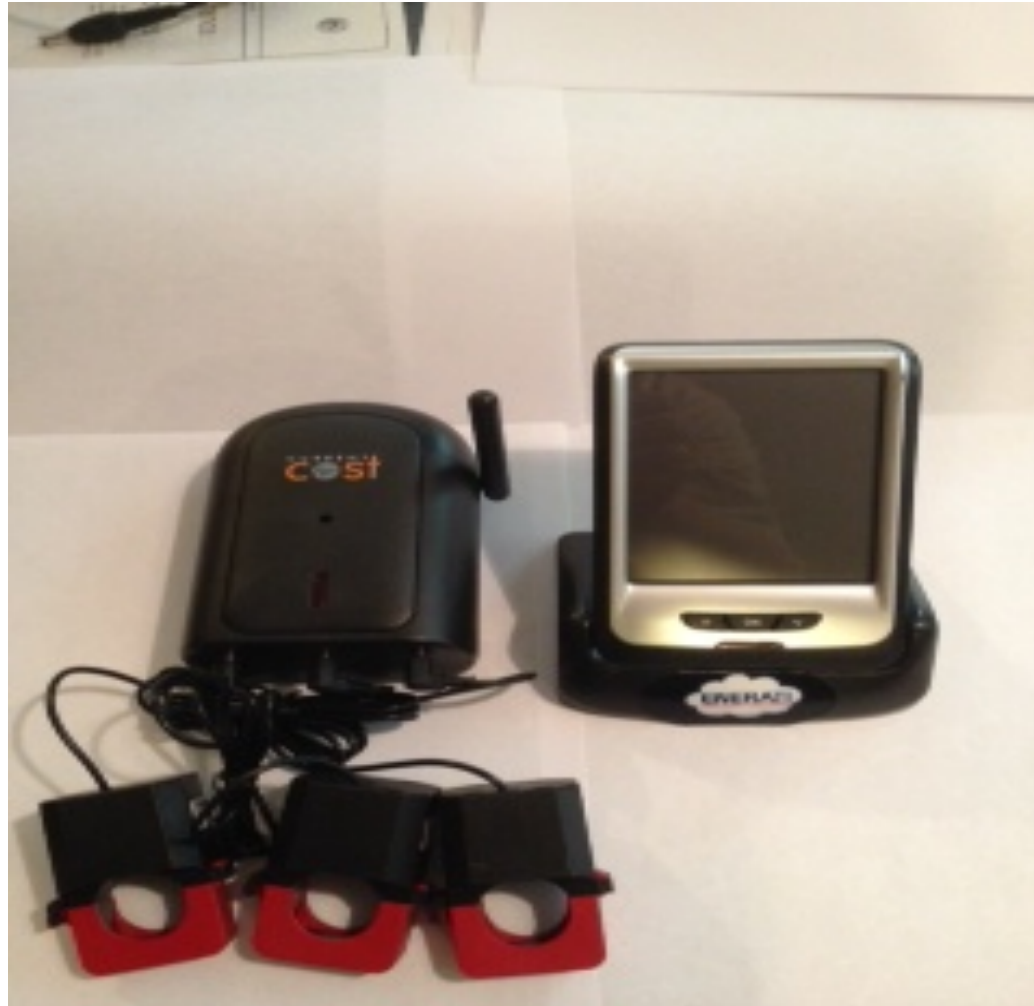
Data Logging Equipment

(Records KWH energy usage)
