Hartsfield-Jackson International Airport

ThermaCote Paint Study

INTERNATIONAL
KNOWLEDGE AND
RESEARCH CENTER
FOR GREEN BUILDING

Hartsfield-Jackson International Airport: ThermaCote Paint Study
International Knowledge and Research Center for Green Building
By: Ian Elmore

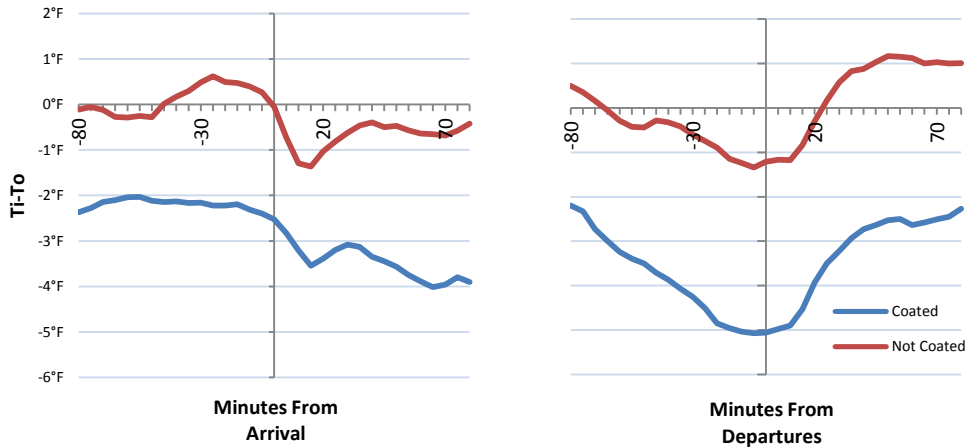
Figure 3

Average Bridge Interior Temperature Relative to Exterior Temperature

Since the length between arrivals and departures vary, looking at the temperatures before, during, and after each arrival and departure (figure 3) reveals the trends during these times (these charts are presented with greater detail in Appendix C).

As the graphs show, temperatures drop quickly in the 10 minutes after arrival, while passengers are disembarking the aircraft and the doors to the concourse are opened. While the non-coated bridge sees temperatures rise back to previous levels, the bridge coated with ThermaCote continues to decline in temperature until boarding (20-30 minutes before departure), when both temperatures drop again.

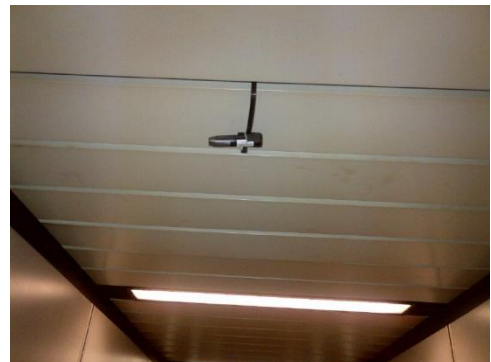
Bridge Data Logger

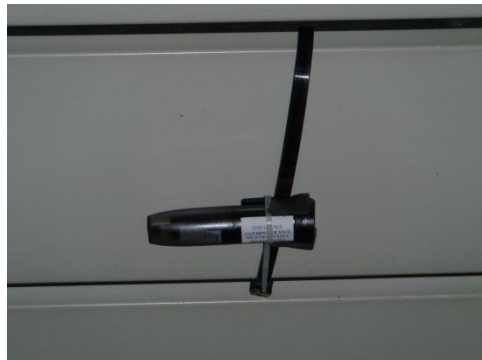
Typical Data Logger installation

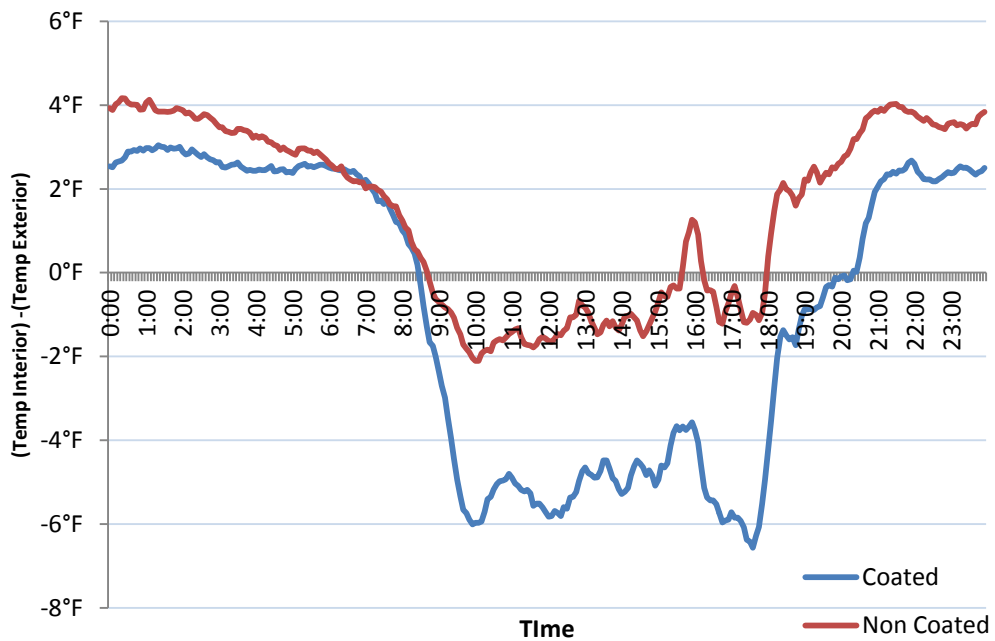
Hourly Average Temperature Difference

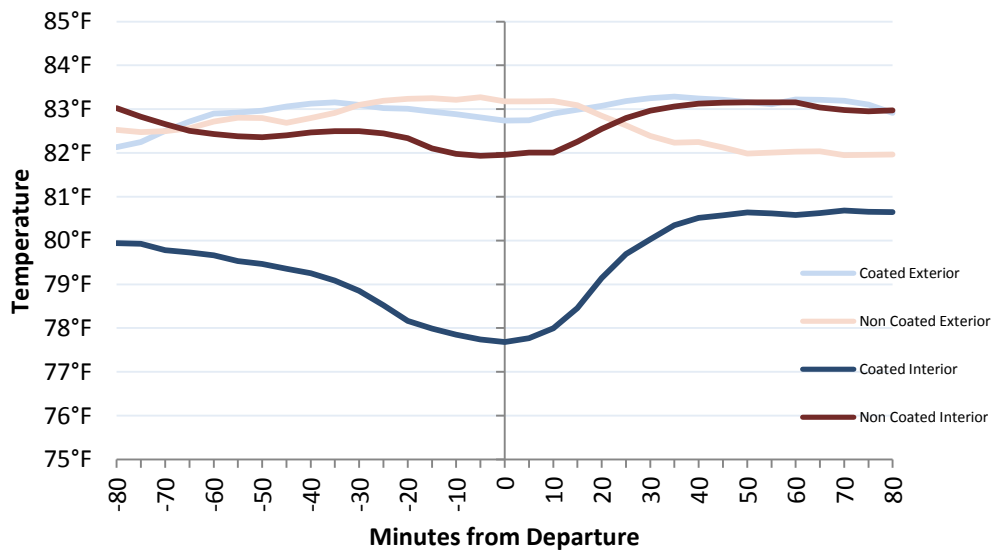
Average Temperatures Relative to Departure
