Hartsfield-Jackson International Airport

ThermaCote Paint Study

Hartsfield-Jackson International Airport: ThermaCote Paint Study
International Knowledge and Research Center for Green Building
By: Ian Elmore

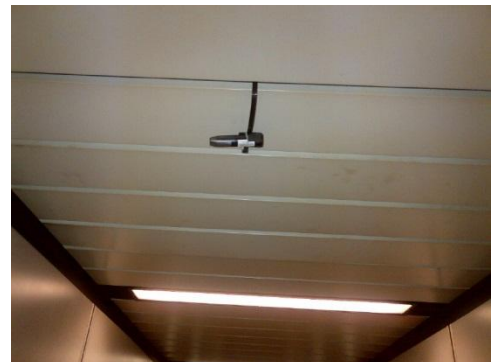
Bridge Data Logger

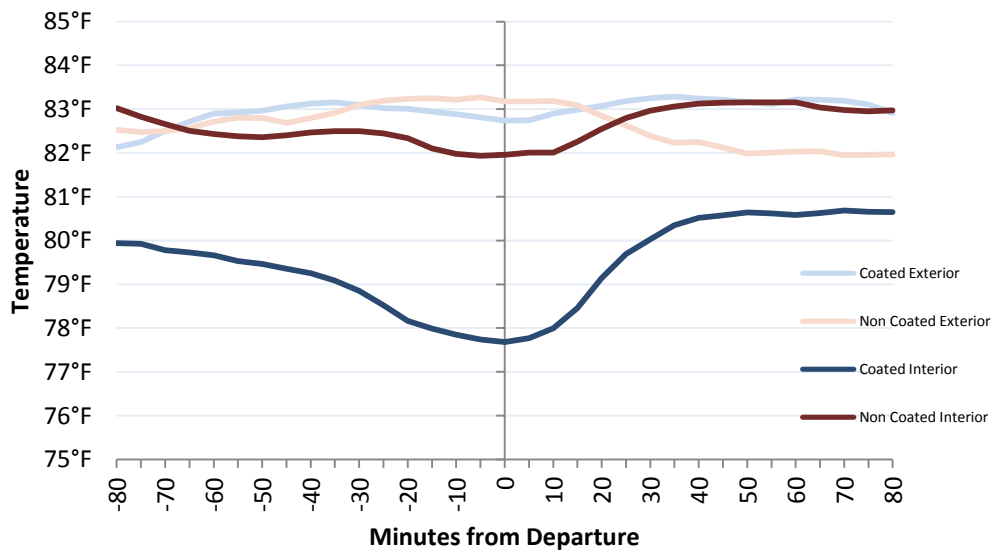
Average Temperatures Relative to Departure

Since the length between arrivals and departures vary, looking at the temperatures before, during, and after each arrival and departure (figure 3) reveals the trends during these times (these charts are presented with greater detail in Appendix C).
